AmirKabir Journal of Science & Research
Mechanical Engineering
(ASJR-ME)

Vol. 48, No. 2, Summer 2016, pp. 57-60

An Investigation of Failure Reasons Of Relief Valves of LPG Gastanks

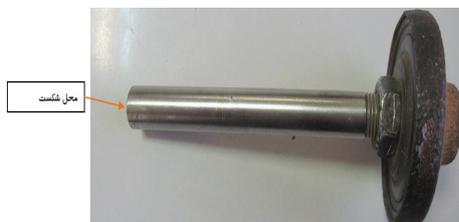
Safety valve, a vital part in gas containers such as LPG or propane, is used to release excessive pressure when the container is overfilled or heated up. This research is focused on parameters responsible for the fracture of one of these safety valves [1]. Figure 1 shows the broken safety valve.

Figure 1. Fracture location in valve

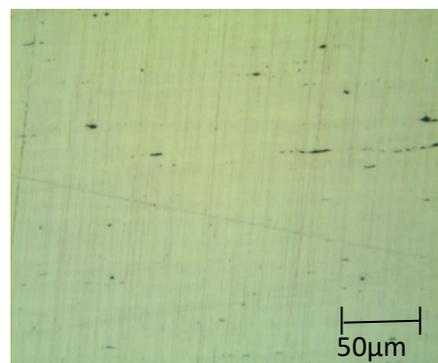
Microstructure evaluation of polished surface of samples (before etch) reveals some amount of elongated gray sulfide particles in the longitudinal direction, a small quantity of nitride and oxide particles in golden yellow and black colors, respectively (Figure 2). Austenite grains with the size of ASTM 9.5 and some portion of transformed martensite

Figure 2. Microstructure after polishing

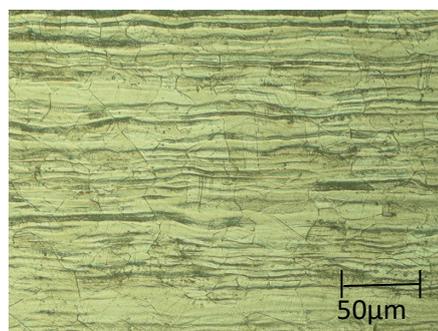
produced by mechanical work were seen after etching samples by kalling solution (Figure 3). Fracture cross section of the failed valve was assessed by stereo and scanning electron microscopes (Figures 4-7). The chemical analysis inside the crack (the crack is shown in Figure 7) was carried out by EDS analysis.

Figure 3. Microstructure after etching

Removing martensite from microstructure could be done by annealing process on specimens. By this process the probability of hydrogen embrittlement will decrease or eliminate.

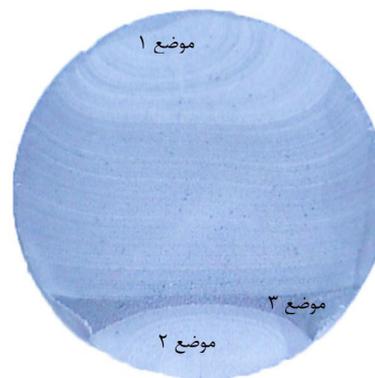
Figure 4. Stereomicroscope image of the fracture surface

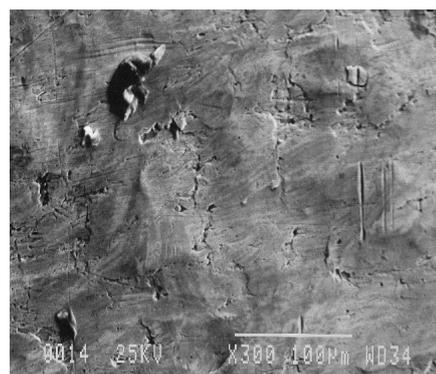
Figure 5. SEM image of microcracks & corrosion voids on surface

Martensite in the microstructure could be responsible for the appearance of hydrogen embrittlement. This assumption may be verified by the observation of micro-cracks on the surface (Figure 5) and in grain boundaries in the fracture surface (Figure 9).

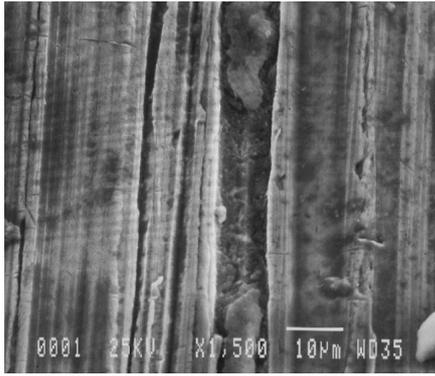
Figure 6. SEM image of coarse machining lines & cavities

Inappropriate machining may cause coarse lines/marks, roughness of surface, micro-cracks, and gouges on the valve surface. These imperfections on the surface are the main evidences which could prove sudden fracture is mainly because of lower fatigue resistance in valves. Furthermore, pits from the corrosion on the surface exacerbate this phenomenon, and finally the valve encounter with fatigue corrosion. Moreover, the presence of a great number of micro-

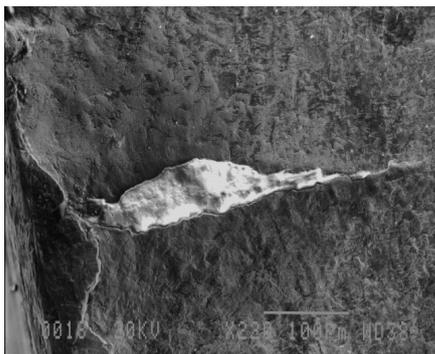
Figure 7. SEM image of ratchet mark on the fracture surface

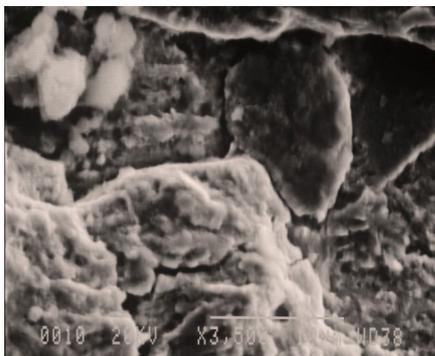
Figure 8. grain boundary cracks on fracture surface

As it may be seemed in Figure 8, high content of carbon is seen at point A. This high amount of carbon is concluded from pitting corrosion products.
