Failure Analysis of a Gas Turbine Blade Made of Inconel 738LC Super Alloy

The blade under evaluation was the second stage blade of a gas turbine. In order to identify the failure root cause, several investigations such as visual inspection, chemical composition analysis, hardness measurement, microstructural characterization and SEM fractography were carried out.

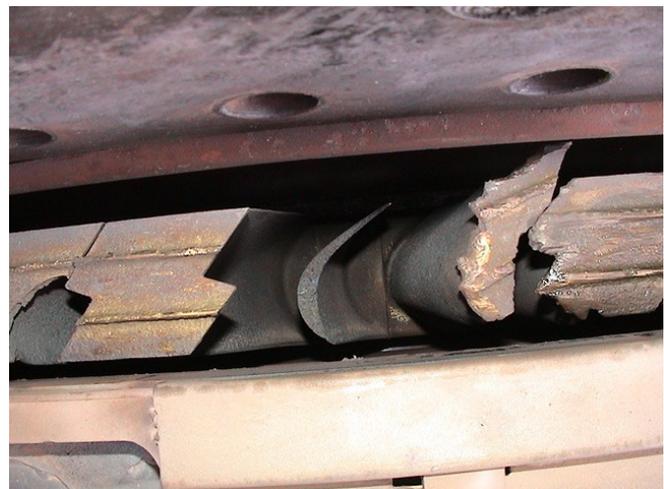
Fig. 1 shows an upper view of the failure occurred in the second stage of the gas turbine.

Figure 1. Upper view of the failed blade.

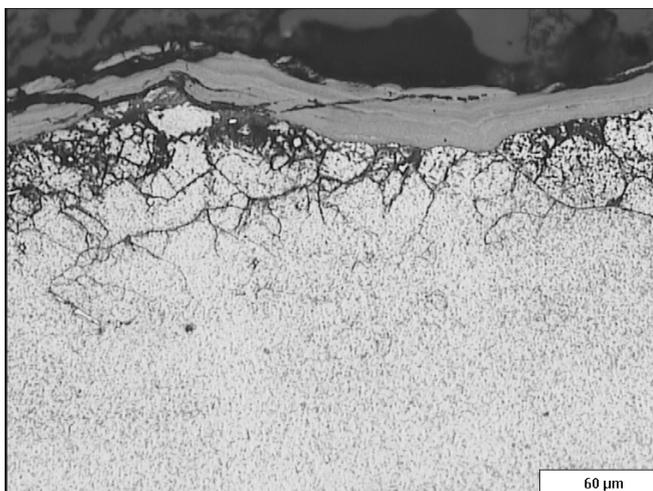
micrograph of the material. There is a relatively compact scale on the surface of the blade. Underneath this scale, a severe deterioration can be noticed. The severity of this deterioration was to a greater degree in the samples of leading edge, especially on the concave surface. Also, the rare precipitation of grain boundary carbides can be seen in Fig. 3.

Figure 2. Surface scale and deterioration of subscale.

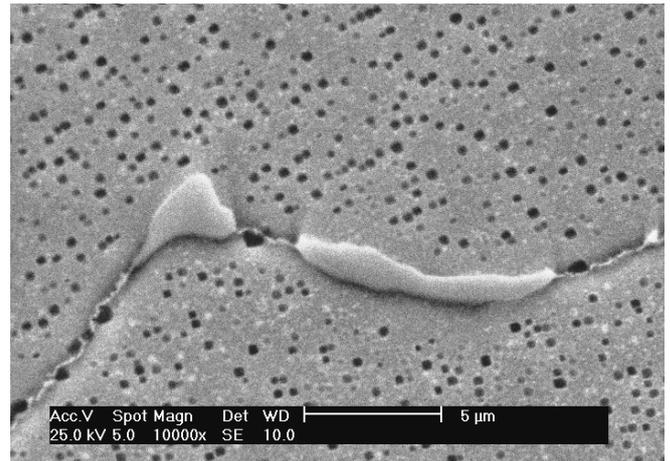
Figure 3. The grain boundary carbides.

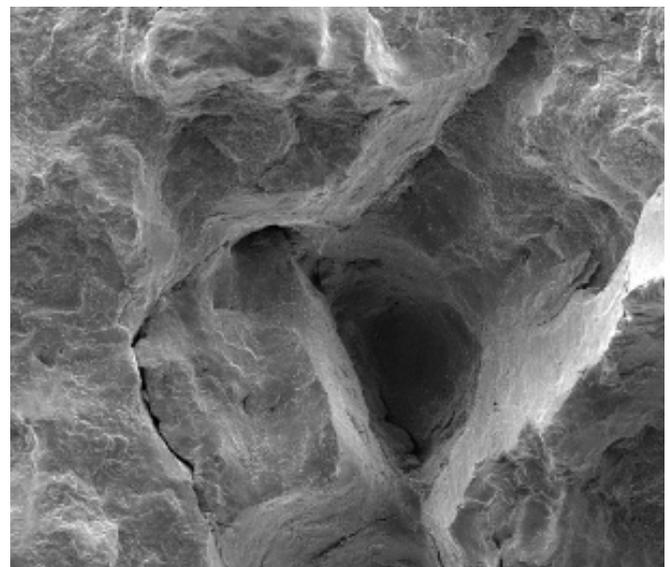
The fracture surface of the failed blade was examined by scanning electron microscope. Fig. 4 shows a crack in the leading edge.

Figure 4. A crack on the surface of the blade (×50).

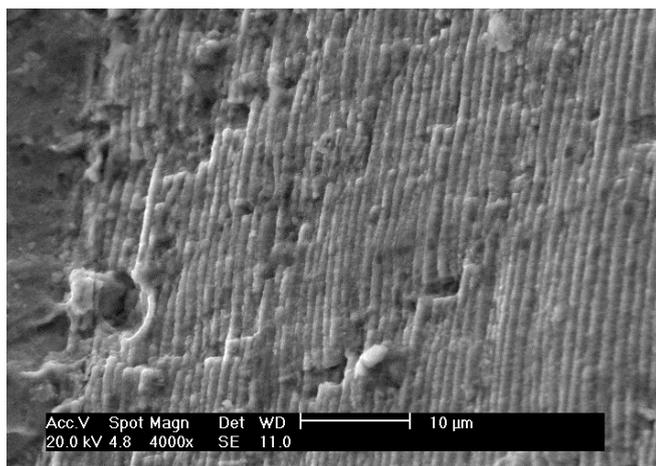
In Fig. 5, fatigue marks (striations) are evident. It indicates that after the initiation of the crack, propagation has been conducted by the fatigue mechanism due to the vibration of the blade. After the crack growth and subsequent reduction in cross-section area, the final fracture occurs in the blade.

Figure 5. Fatigue striations ($\times 4000$).

1. Control of unit start-ups, shut-downs, and trips.
2. Using high-quality fuel.
3. Manufacturing of blade by direction solidification method.
4. Using thermal barrier coating.
