# Numerical Analysis of the Effect of Natural Convection Heat Transfer on the Gas Turbine Axial Compressor Casing

M. Valizadeh<sup>1\*</sup>, M. Behnia<sup>1</sup>, A. Shahrabi Farahani<sup>1</sup>, H. Khaledi<sup>2</sup>

<sup>1</sup> Department of Compressor, Turbotec Company, Tehran, Iran

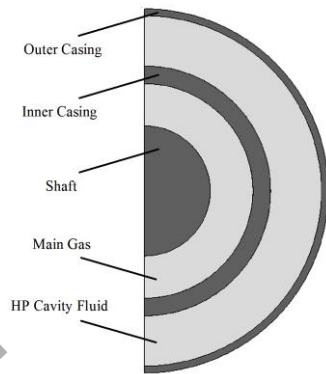
Fig. 1. Hybrid turbine model

outer casing, with the shaft and the fluid between them, are modeled as concentric cylinders. In this case, due to the fact that the flow rate only exists in the early stages of the shutdown and is very low, the flow rate in the axial direction is neglected. In Fig 1, the geometry of the two-dimensional model is shown. Since the geometry and applied boundary conditions are quite symmetrical to the vertical axis, half of the geometry is modeled to accelerate the process of solution.

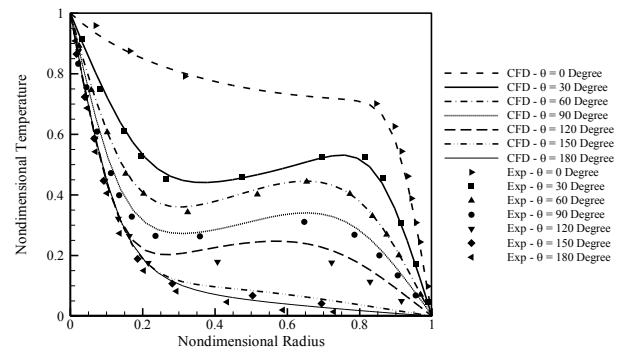
Fig. 2. The flow field and boundary conditions

study, a model is simulated based on the experimental results of Kuehn and Goldstein [2]. Fig. 2 shows the dimensionless temperature in terms of the dimensionless radius in several different angles for experimental results [2] and the numerical results of the present study. Angles 0 and 180 degrees represent the uppermost and lowermost points of the casing, respectively. As it is clear from Fig. 2, the results of the numerical study are in good agreement with the experimental data.
